PRELIMINARY ASSESSMENT REPORT
For
SBA SHIPYARD
JENNINGS, JEFFERSON DAVIS PARISH, LOUISIANA

Prepared for
U.S. Environmental Protection Agency Region 6
1445 Ross Avenue
Dallas, Texas 75202

June 3, 2013

Prepared by
Dynamac Corporation
1323 Columbia Drive, Suite 307
Richardson, Texas 75081
(214) 575-3344

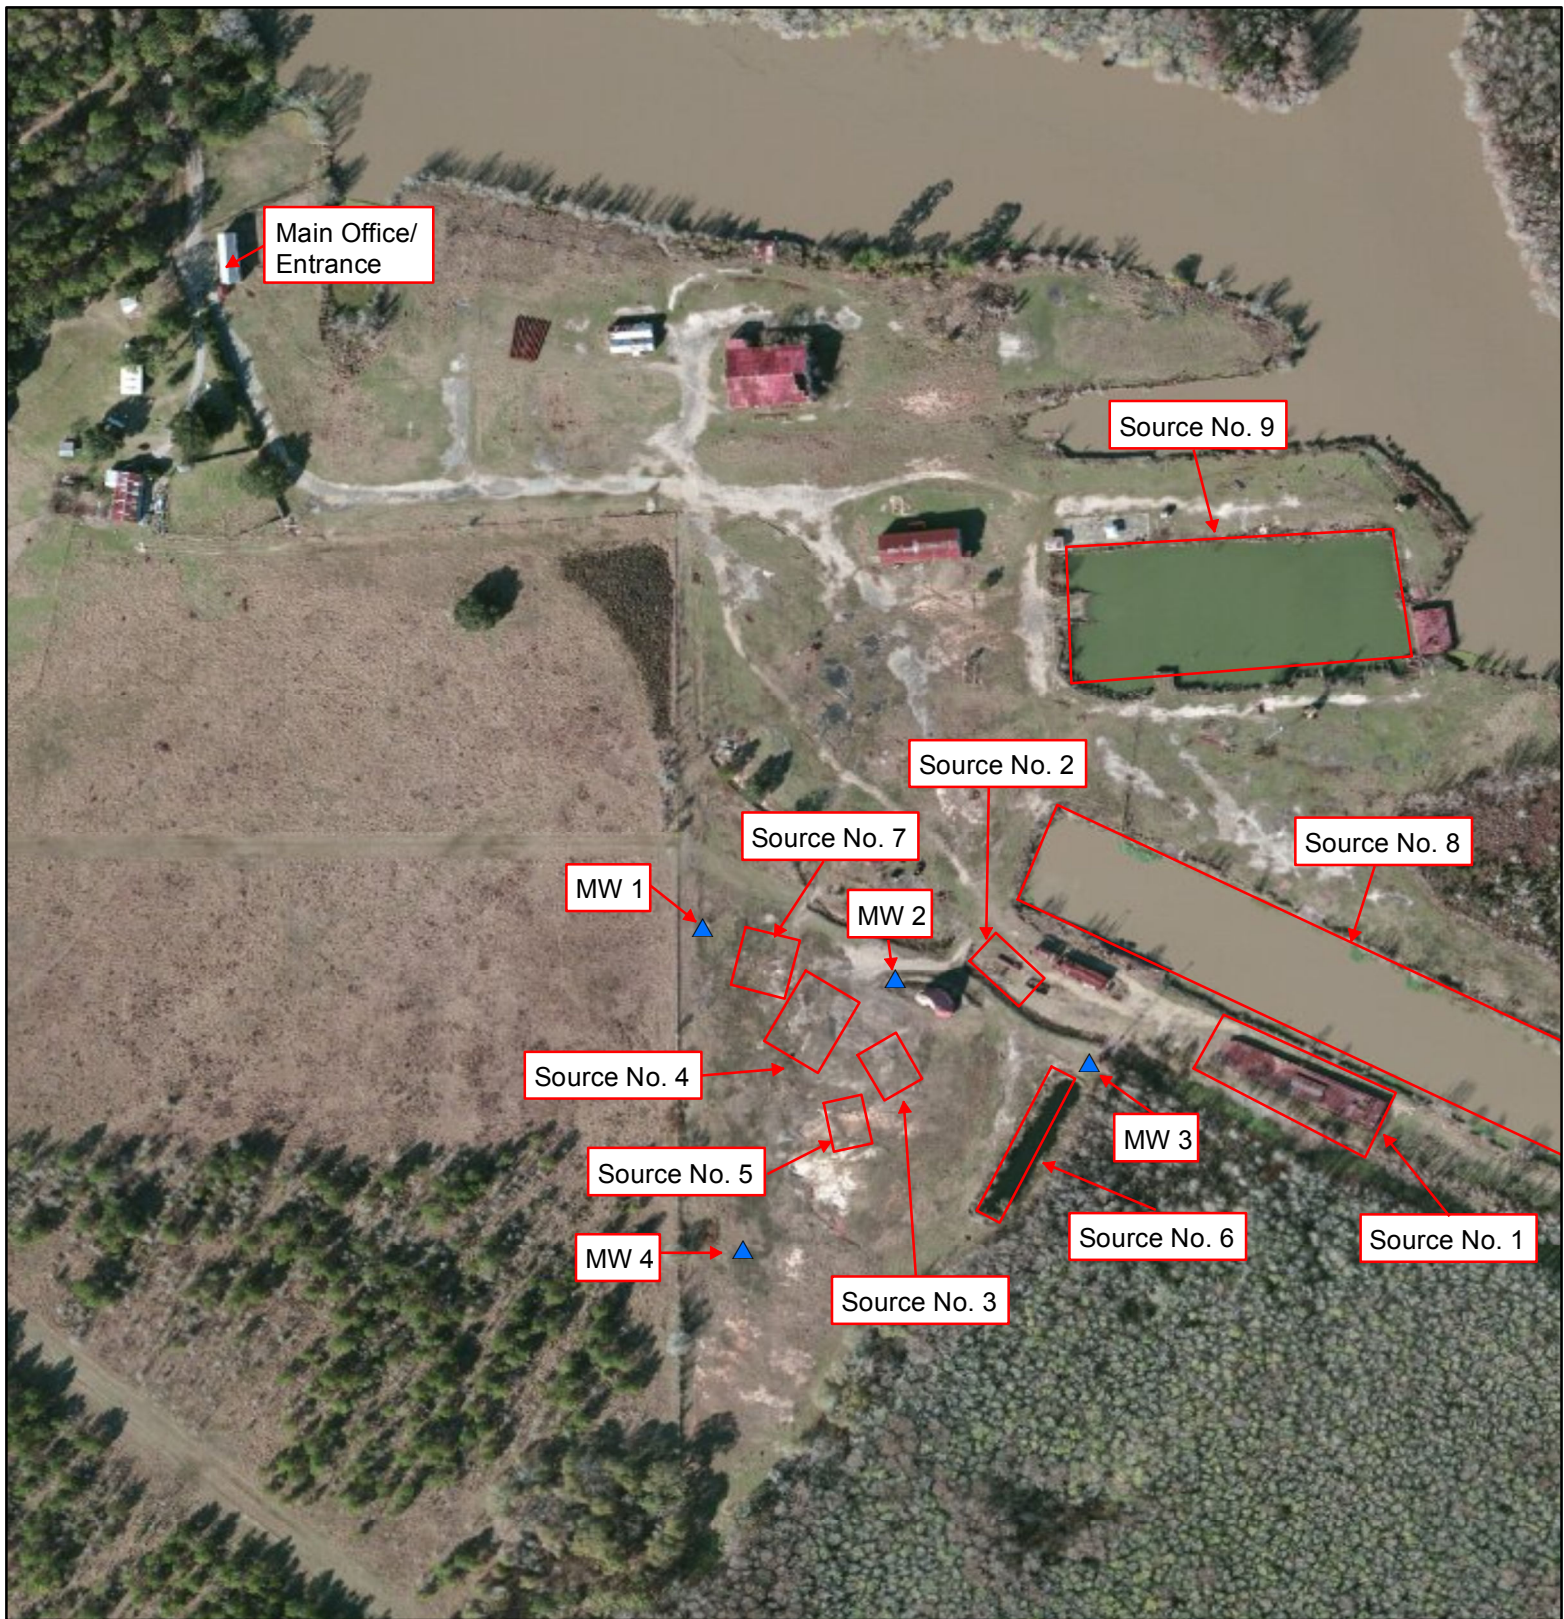
Figure 3. Site Sketch (SBA Shipyard)

The area of interest (AOI) in SBA Shipyard consists of an abandoned buried barge southeast of the property, adjacent to a wetland and the west bank of the Mermentau River in Jennings, LA (Figures 3 and 4).

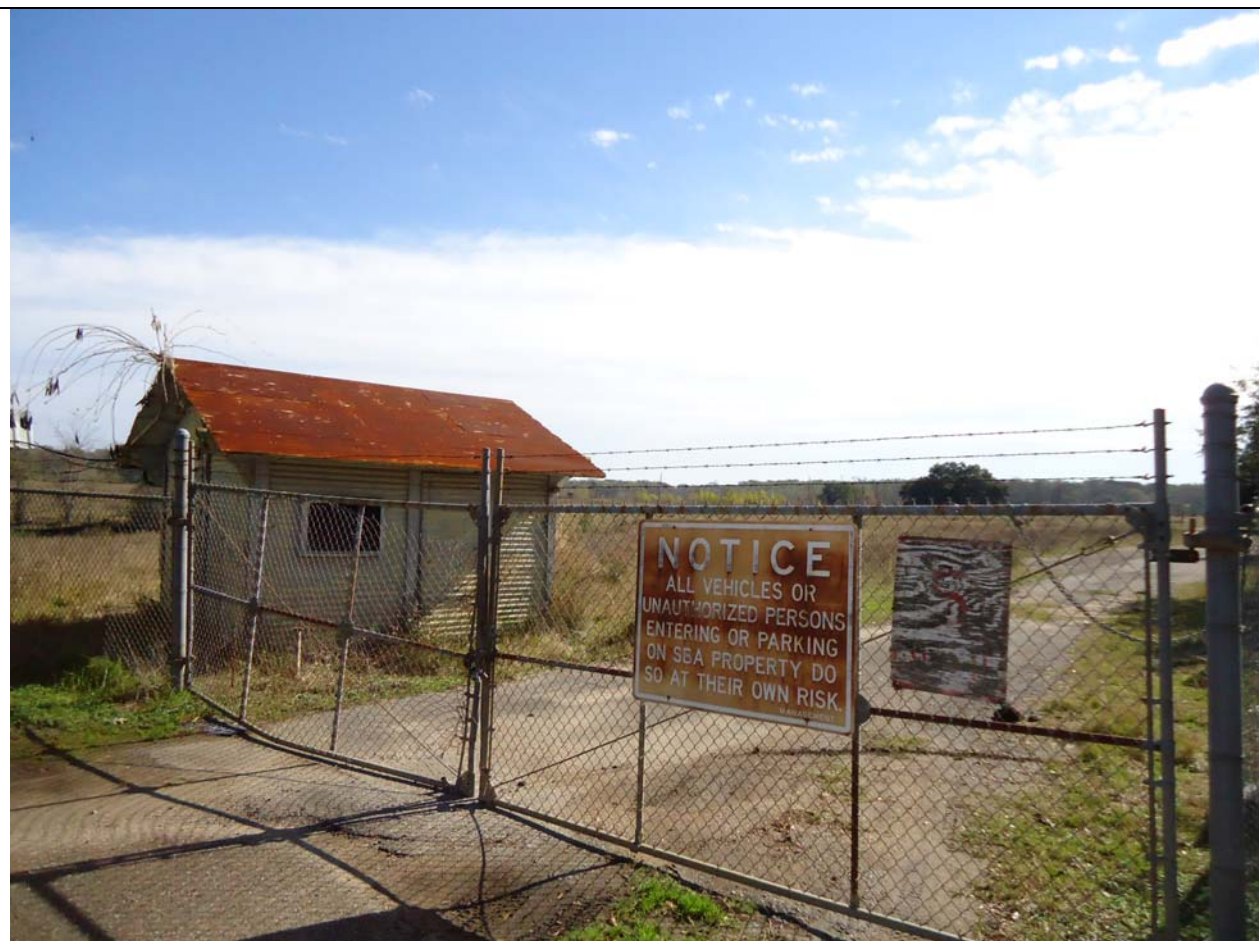
Logbook Photo #	DSC00150
US EPA CERCLIS No / Task Order Number	LAD008434185 / TO-0009-12-10-02
Site	SBA Shipyard
Location Address	9040 Castex Landing Road
City, State	Jennings, Louisiana 70546
Parish	Jefferson Davis
Direction/Orientation	South
Date	12/11/12
Time	1152
Photographer	N. Biscocho (START)
Witness	K. Lloyd (START)
Description:	
Entrance to the site.

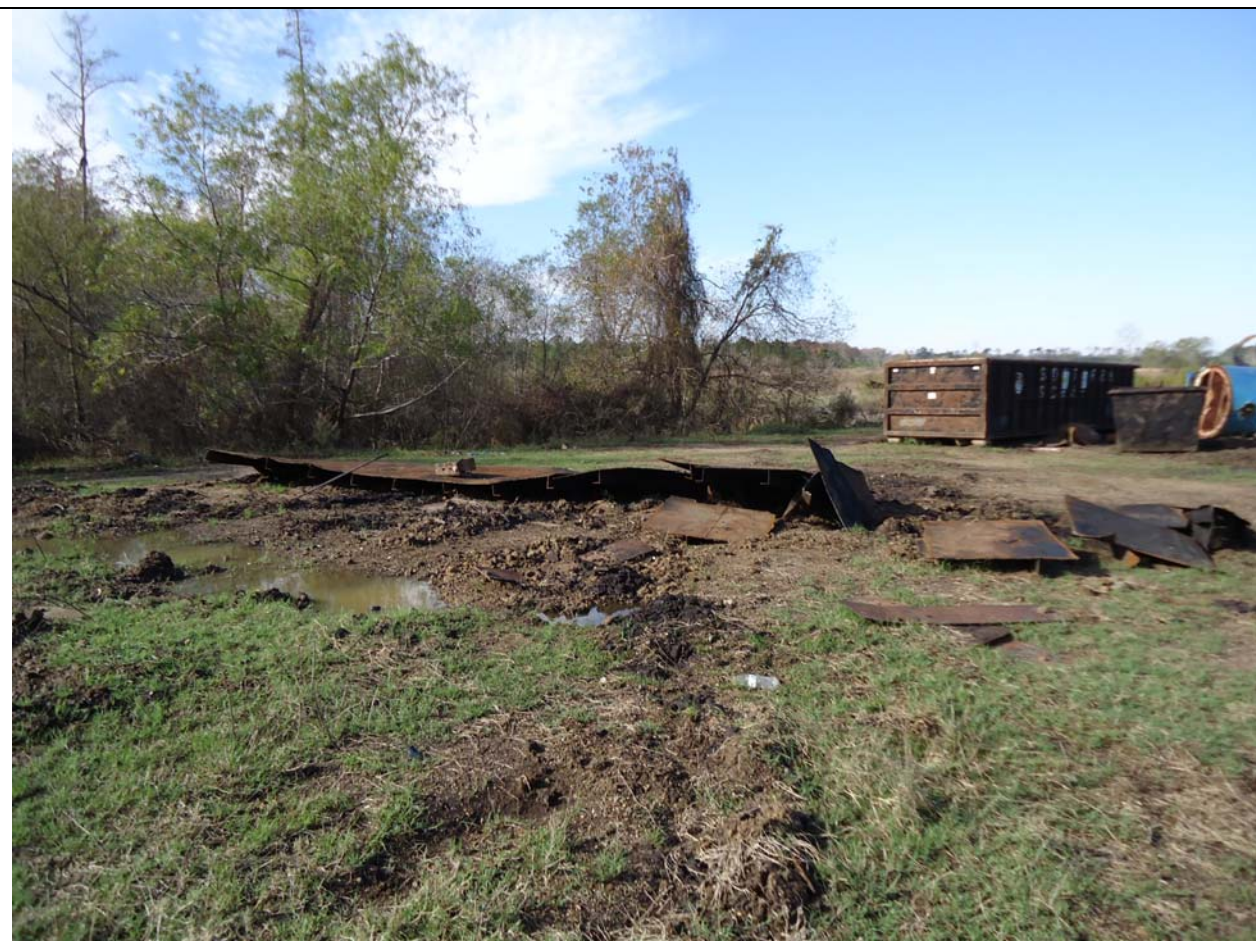
treatment unit were not observed during the reconnaissance. Four monitoring wells were present on the western portion of the property. A partially buried barge, an asphalt tank, and partially scrapped metal from a former 10,000 barrel tank remained onsite.

Logbook Photo #	DSC00103
US EPA CERCLIS No / Task Order Number	LAD008434185 / TO-0009-12-10-02
Site	SBA Shipyard
Location Address	9040 Castex Landing Road
City, State	Jennings, Louisiana 70546
Parish	Jefferson Davis
Direction/Orientation	North
Date	12/11/12
Time	0947
Photographer	K. Lloyd (START)
Witness	N. Biscocho (START)
Description:	
Scrap metal NW of barge.

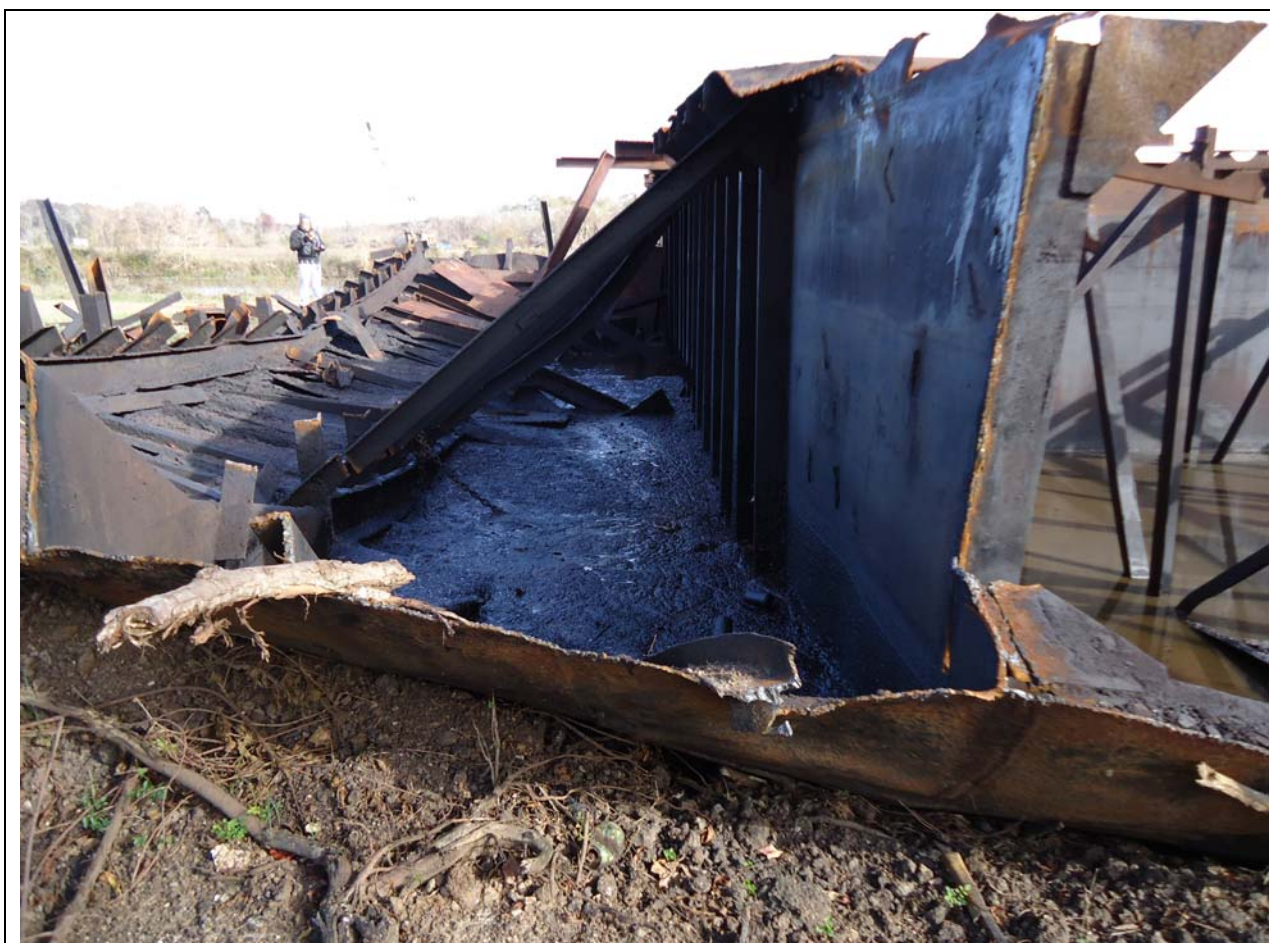
- Source No. 1 is a partially buried barge. The barge is approximately 250 feet (ft.) by 50 ft. The steel barge is located on the southeast portion of the property, north of a designated wetland area. Waste oil and fluids from the barge are being released into the aforementioned wetlands (Appendix C). An anonymous caller notified the National Response Center (NRC) in October 2012 that the barge was being scrapped and oil was being discharged to the surrounding soils. The material was also allowed to burn (Ref. 22). LDEQ conducted an investigation and reported evidence of the scrapping efforts. The burning had been extinguished (Ref. 23).

Logbook Photo #	DSC00108
US EPA CERCLIS No / Task Order Number	LAD008434185 / TO-0009-12-10-02
Site	SBA Shipyard
Location Address	9040 Castex Landing Road
City, State	Jennings, Louisiana 70546
Parish	Jefferson Davis
Direction/Orientation	North
Date	12/11/12
Time	0949
Photographer	K. Lloyd (START)
Witness	N. Biscocho (START)
Description: Product in barge.

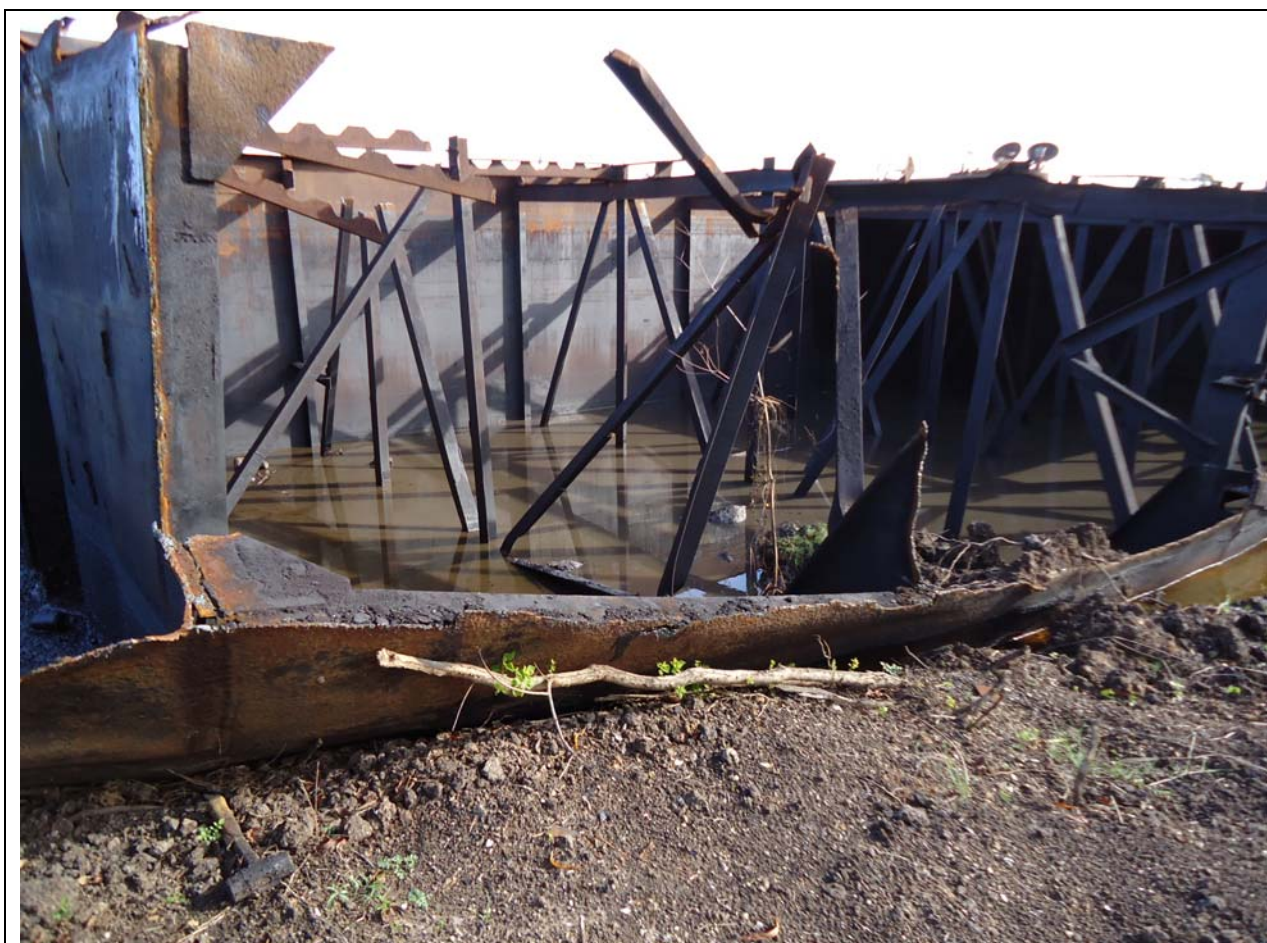
Logbook Photo #	DSC00109
US EPA CERCLIS No / Task Order Number	LAD008434185 / TO-0009-12-10-02
Site	SBA Shipyard
Location Address	9040 Castex Landing Road
City, State	Jennings, Louisiana 70546
Parish	Jefferson Davis
Direction/Orientation	North
Date	12/11/12
Time	0949
Photographer	K. Lloyd (START)
Witness	N. Biscocho (START)
Description: Second compartment of barge.

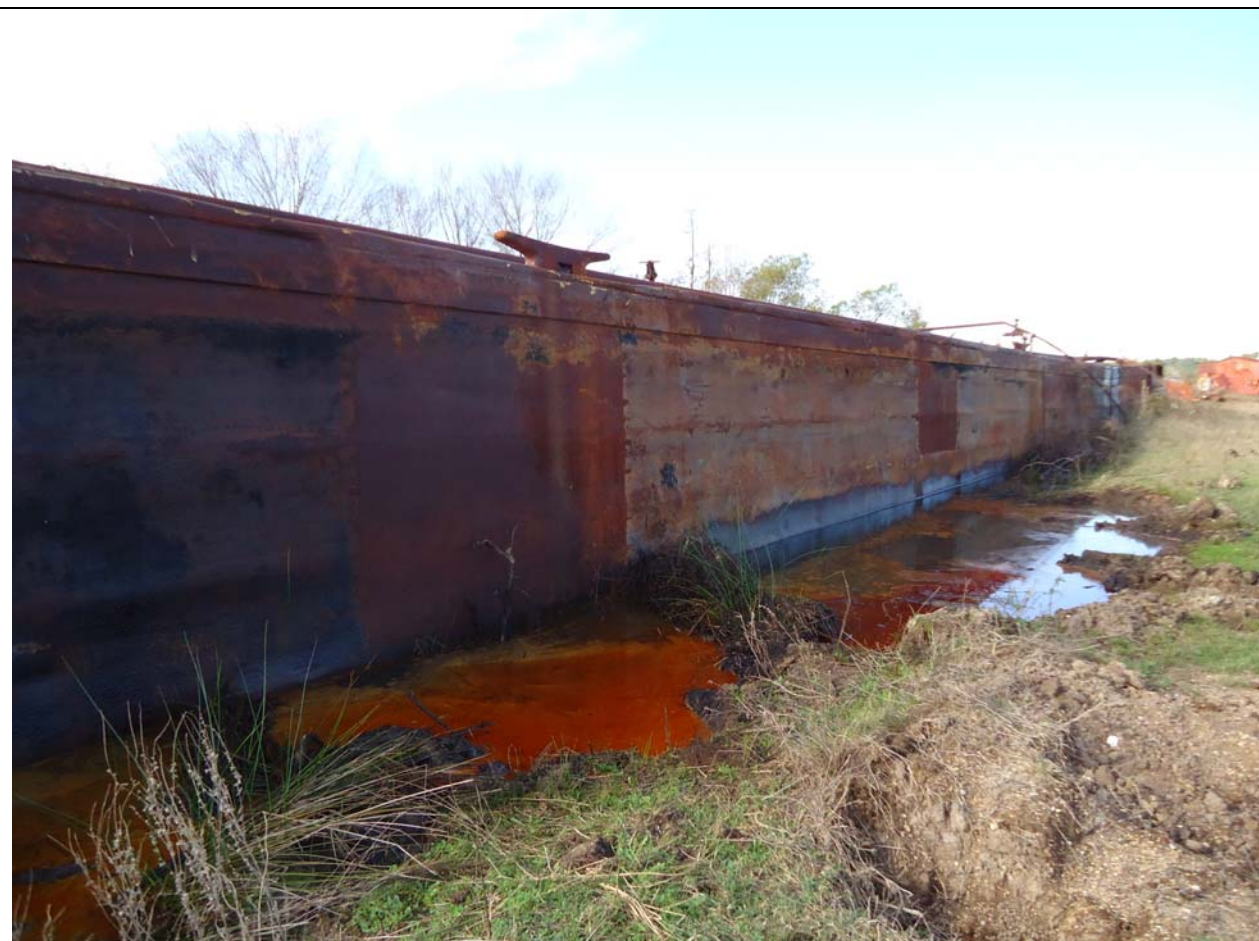
Contents from the barge have been observed entering into the wetlands located approximately 30 feet to the southwest (Appendix C). The two-year, 24-hour rainfall for the area of the site is approximately 5.0 to 5.5 inches (Ref. 19, p. 2). The AOI is located in a 100-year floodplain (Ref. 20).

Logbook Photo #	DSC00113
US EPA CERCLIS No / Task Order Number	LAD008434185 / TO-0009-12-10-02
Site	SBA Shipyard
Location Address	9040 Castex Landing Road
City, State	Jennings, Louisiana 70546
Parish	Jefferson Davis
Direction/Orientation	NW
Date	12/11/12
Time	0954
Photographer	K. Lloyd (START)
Witness	N. Biscocho (START)
Description: Sheen on east side of barge.

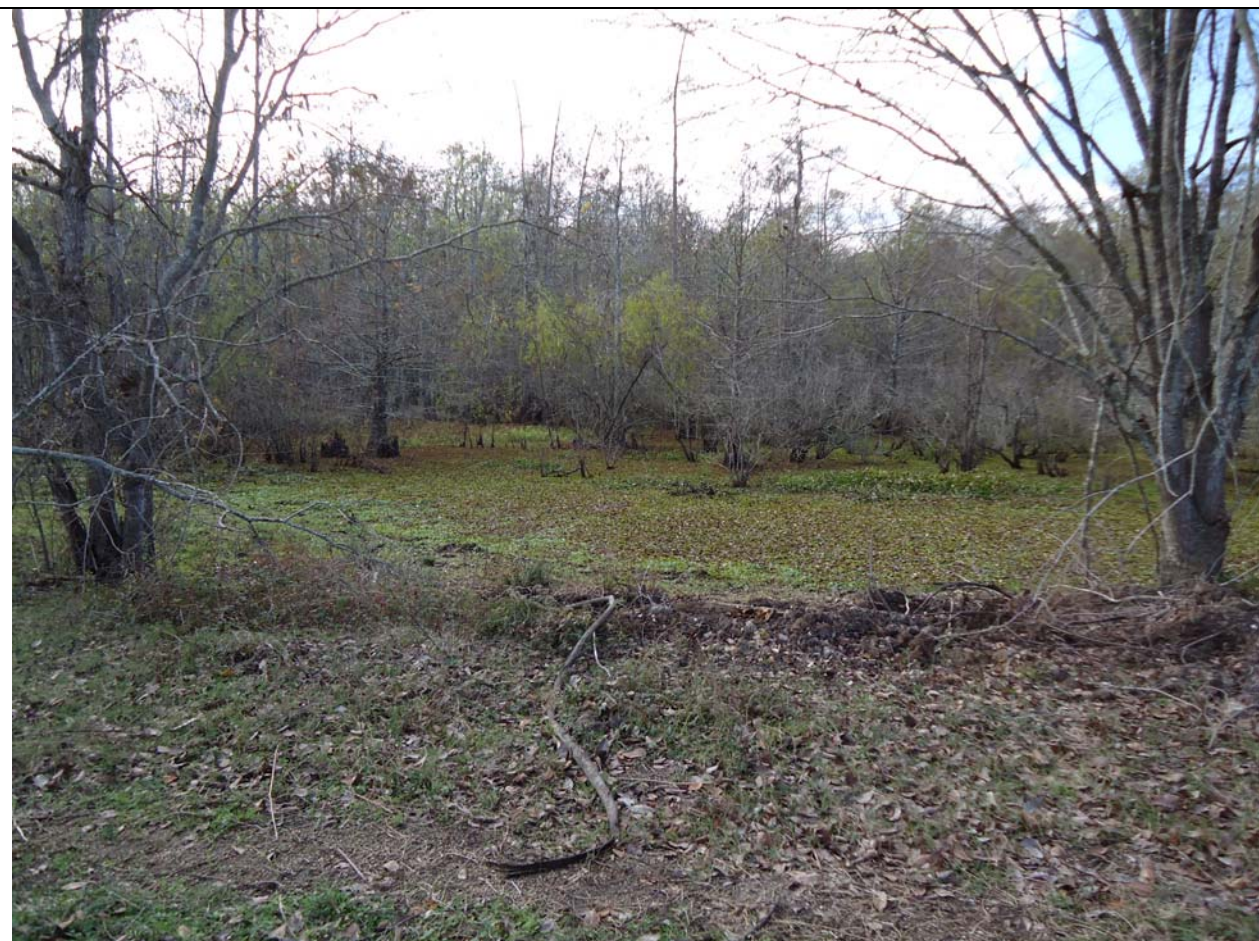
The probable point of entry (PPE) for the 15-mile surface water pathway is the wetlands on the Mermentau River directly south of the abandoned buried barge on the SBA property. Mermentau River flows for approximately 6.63 miles until it enters Lake Arthur. The remainder of the 15-mile surface water pathway continues throughout Lake Arthur (Figure 6).

Logbook Photo #	DSC00114
US EPA CERCLIS No / Task Order Number	LAD008434185 / TO-0009-12-10-02
Site	SBA Shipyard
Location Address	9040 Castex Landing Road
City, State	Jennings, Louisiana 70546
Parish	Jefferson Davis
Direction/Orientation	South
Date	12/11/12
Time	1003
Photographer	K. Lloyd (START)
Witness	N. Biscocho (START)
Description: Wetlands (Probable Point of Entry - PPE - from barge discharge)

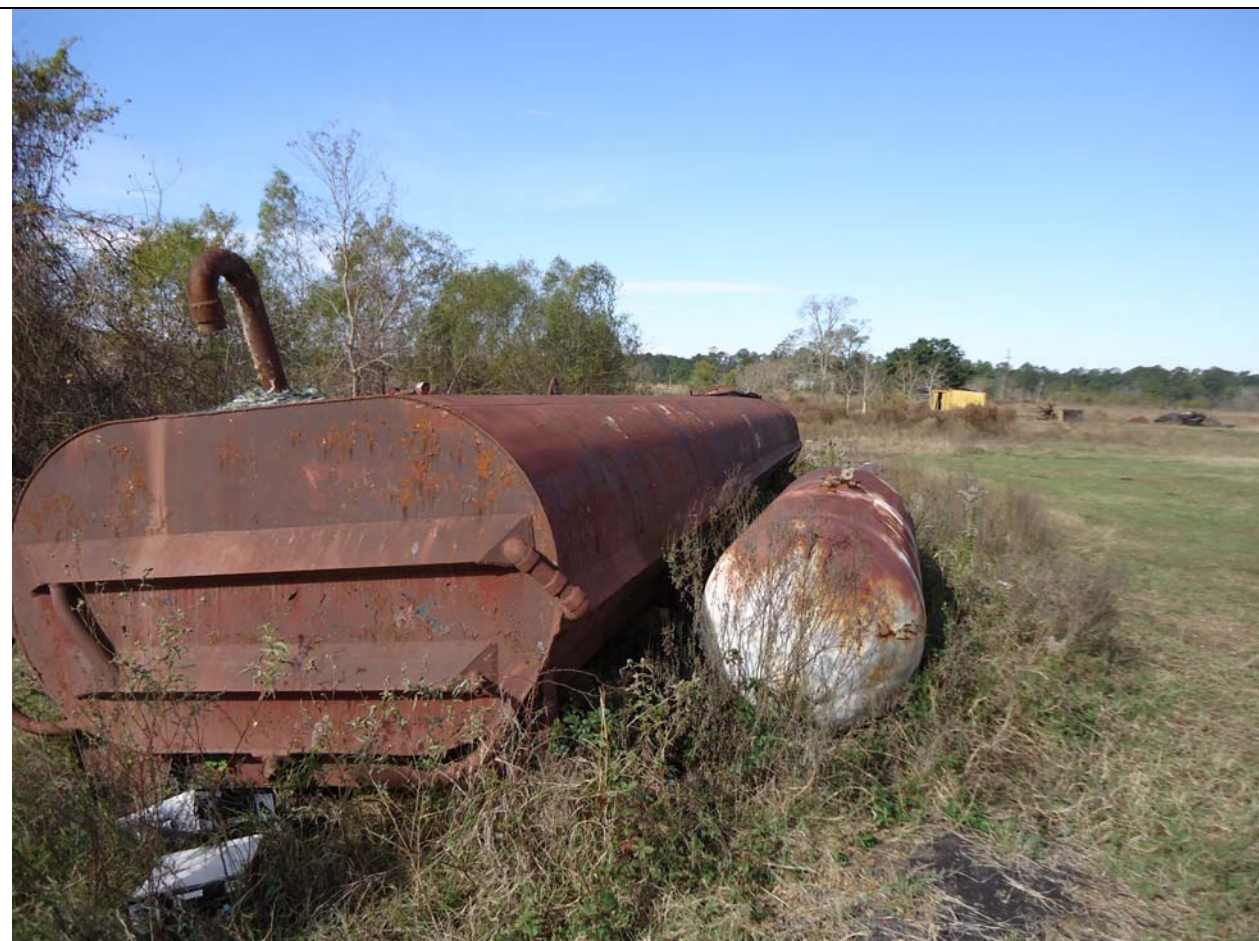
- Source No. 2 is a horizontal steel, aboveground storage tank (AST). The tank is located approximately 300 feet northwest of the barge. It allegedly contains approximately 50,000 pounds of solid asphaltic material. No secondary containment features are associated with the AST.

Logbook Photo #	DSC00120
US EPA CERCLIS No / Task Order Number	LAD008434185 / TO-0009-12-10-02
Site	SBA Shipyard
Location Address	9040 Castex Landing Road
City, State	Jennings, Louisiana 70546
Parish	Jefferson Davis
Direction/Orientation	Northeast
Date	12/11/12
Time	1015
Photographer	K. Lloyd (START)
Witness	N. Biscocho (START)
Description: AST (asphalt) and propane tank.

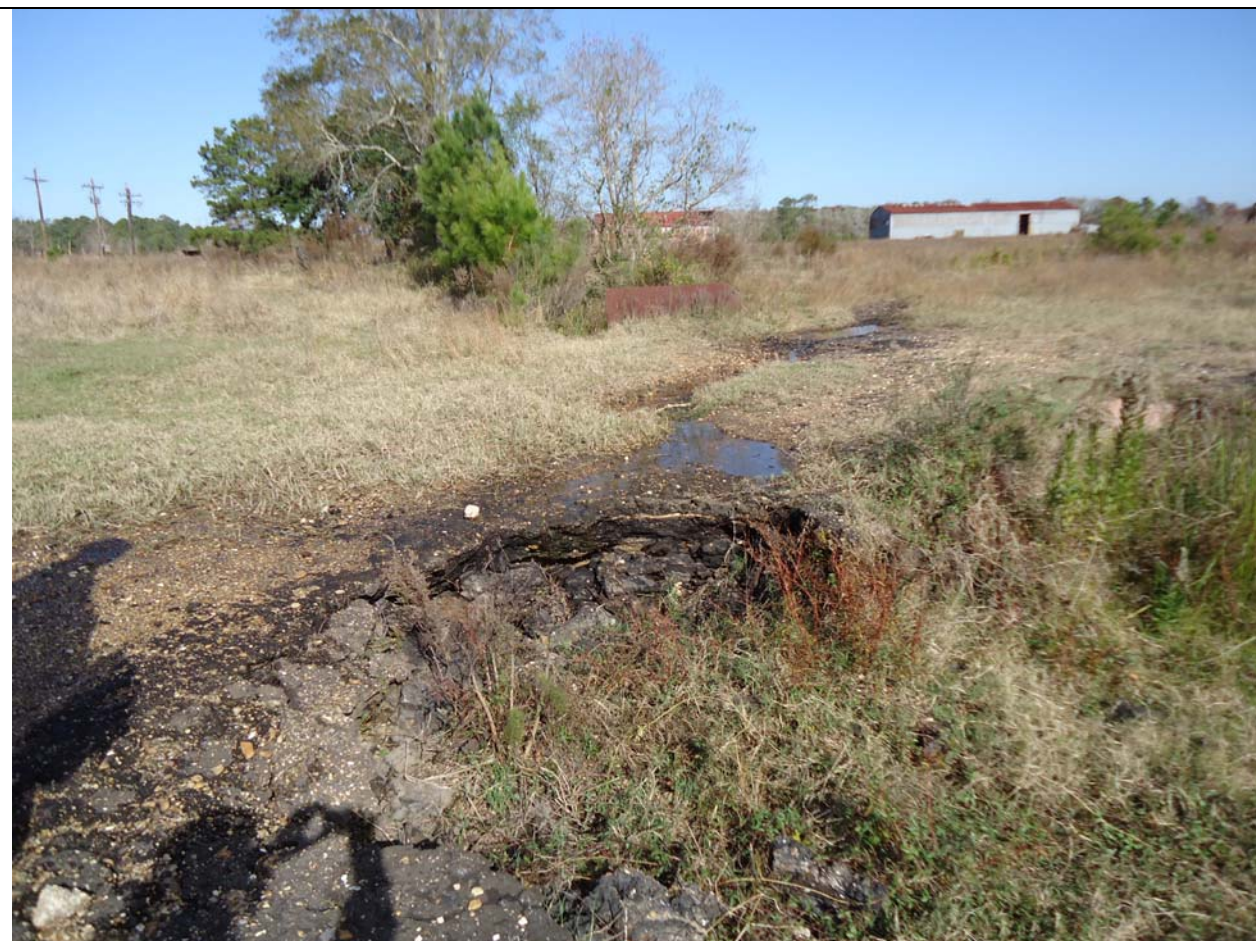
Logbook Photo #	DSC00127
US EPA CERCLIS No / Task Order Number	LAD008434185 / TO-0009-12-10-02
Site	SBA Shipyard
Location Address	9040 Castex Landing Road
City, State	Jennings, Louisiana 70546
Parish	Jefferson Davis
Direction/Orientation	NE
Date	12/11/12
Time	1024
Photographer	K. Lloyd (START)
Witness	N. Biscocho (START)
Description: Asphaltic material used for road.

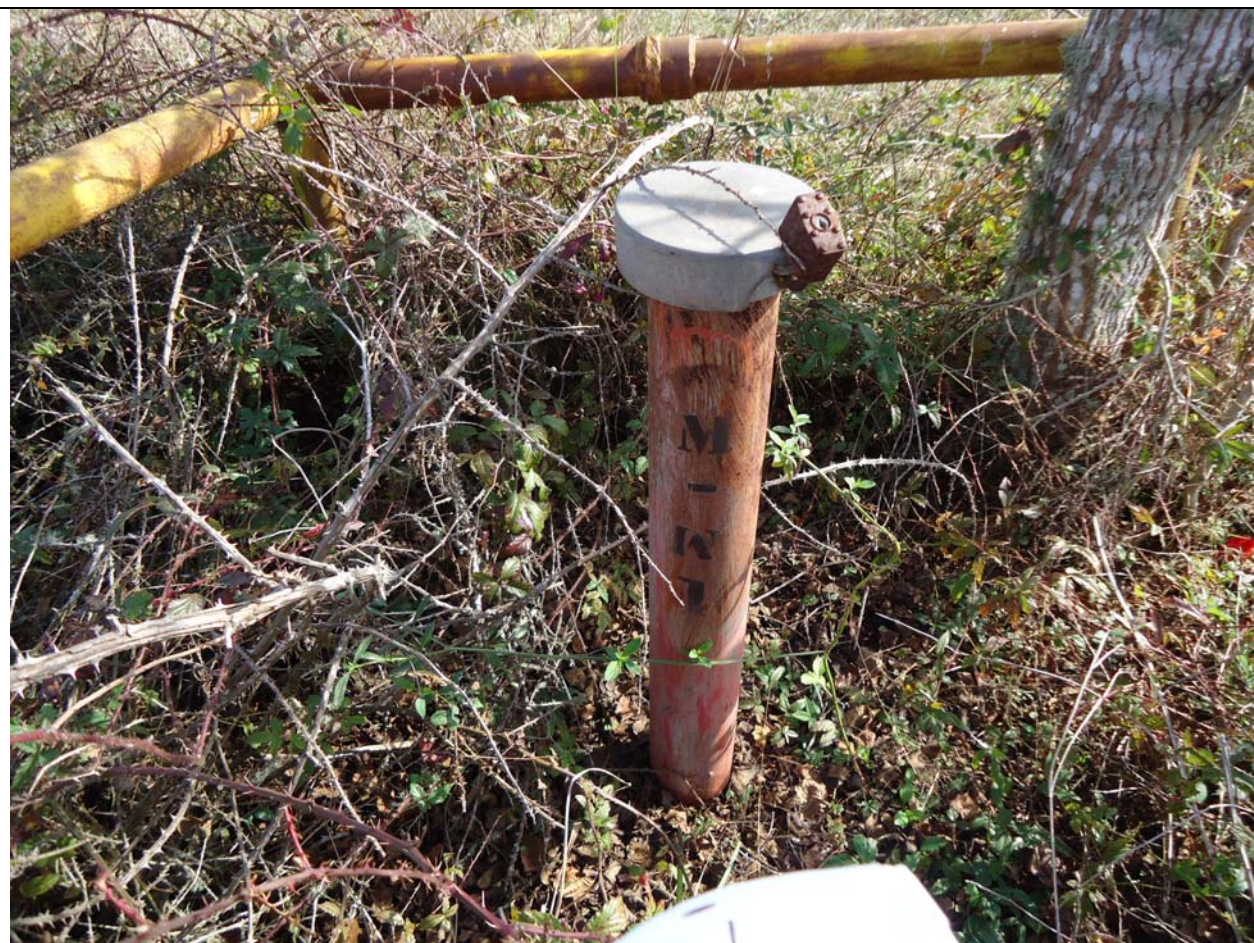
Four monitoring wells were installed at SBA in 1989. The reported depths range from 26.9 feet bgs to 30 ft. bgs. They are screened from 15 to 25 ft. bgs (Ref. 10, p. 12). Silty clays and clays containing discontinuous lenses, pockets, and layers of silt or fine sand were encountered during well installation (Ref. 10, p. 10, Appendix A). The permeability of the units encountered ranged from 4.52×10^{-7} centimeters per second (cm/sec) at a 12-14 ft. bgs interval to 4.52×10^{-9} cm/sec at a 28-30 ft. bgs interval (Ref. 10, p. 10). The wells were installed to monitor the groundwater in the vicinity of the impoundments. They were periodically sampled and analyzed for VOCs and SVOCs. The analytical data in the LDEQ files show that the ground water in the shallow water bearing unit was contaminated with VOCs and SVOCs (Ref. 10, pp. 22, 23). According to the available documentation, none of the nearby private water wells have been analyzed for VOCs or SVOCs.

Logbook Photo #	DSC00130
US EPA CERCLIS No / Task Order Number	LAD008434185 / TO-0009-12-10-02
Site	SBA Shipyard
Location Address	9040 Castex Landing Road
City, State	Jennings, Louisiana 70546
Parish	Jefferson Davis
Direction/Orientation	East
Date	12/11/12
Time	1039
Photographer	K. Lloyd (START)
Witness	N. Biscocho (START)
Description: Monitor Well 1 (zoom-in)

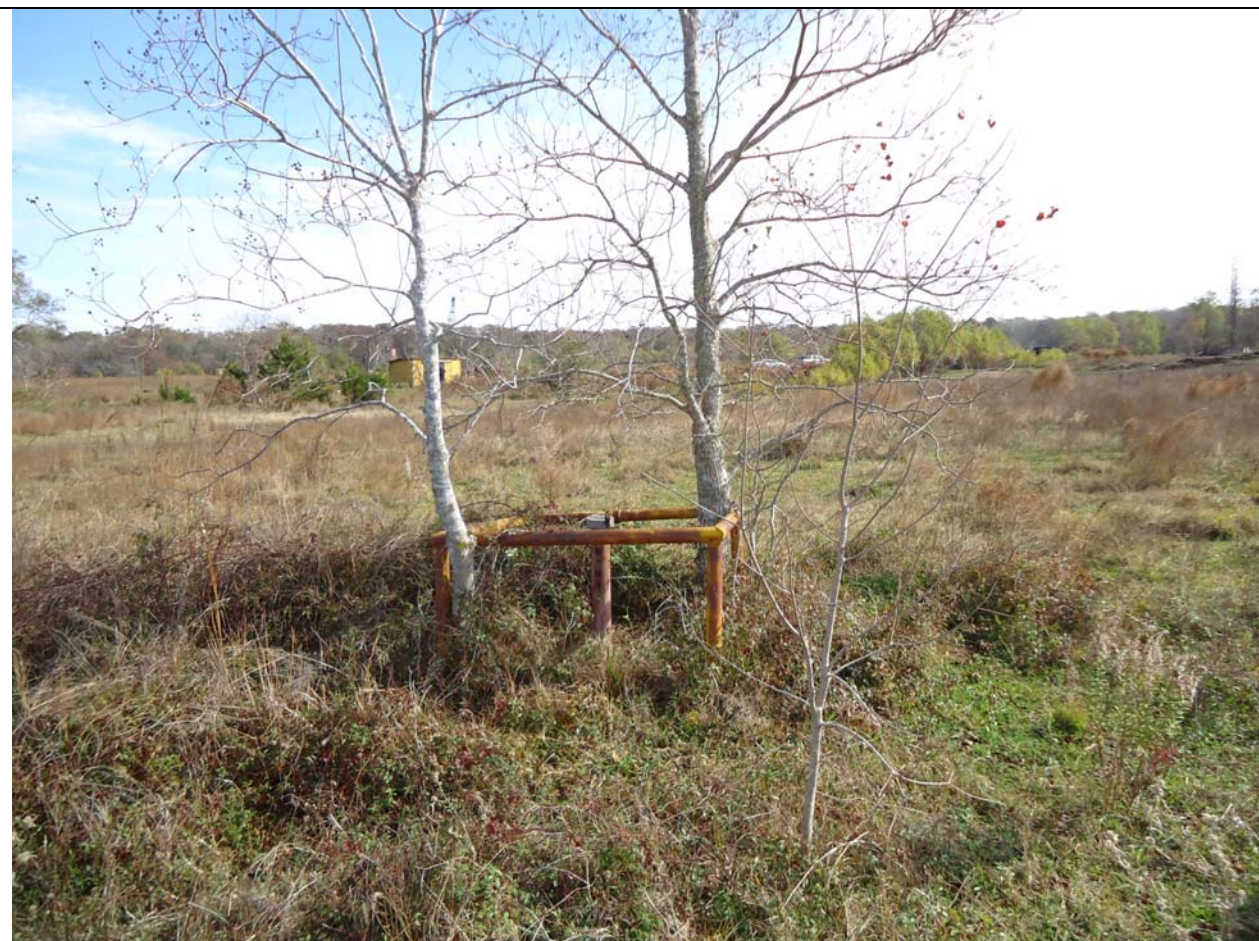
Logbook Photo #	DSC00131
US EPA CERCLIS No / Task Order Number	LAD008434185 / TO-0009-12-10-02
Site	SBA Shipyard
Location Address	9040 Castex Landing Road
City, State	Jennings, Louisiana 70546
Parish	Jefferson Davis
Direction/Orientation	East
Date	12/11/12
Time	1039
Photographer	K. Lloyd (START)
Witness	N. Biscocho (START)
Description: Monitor Well 1 (zoom-out)

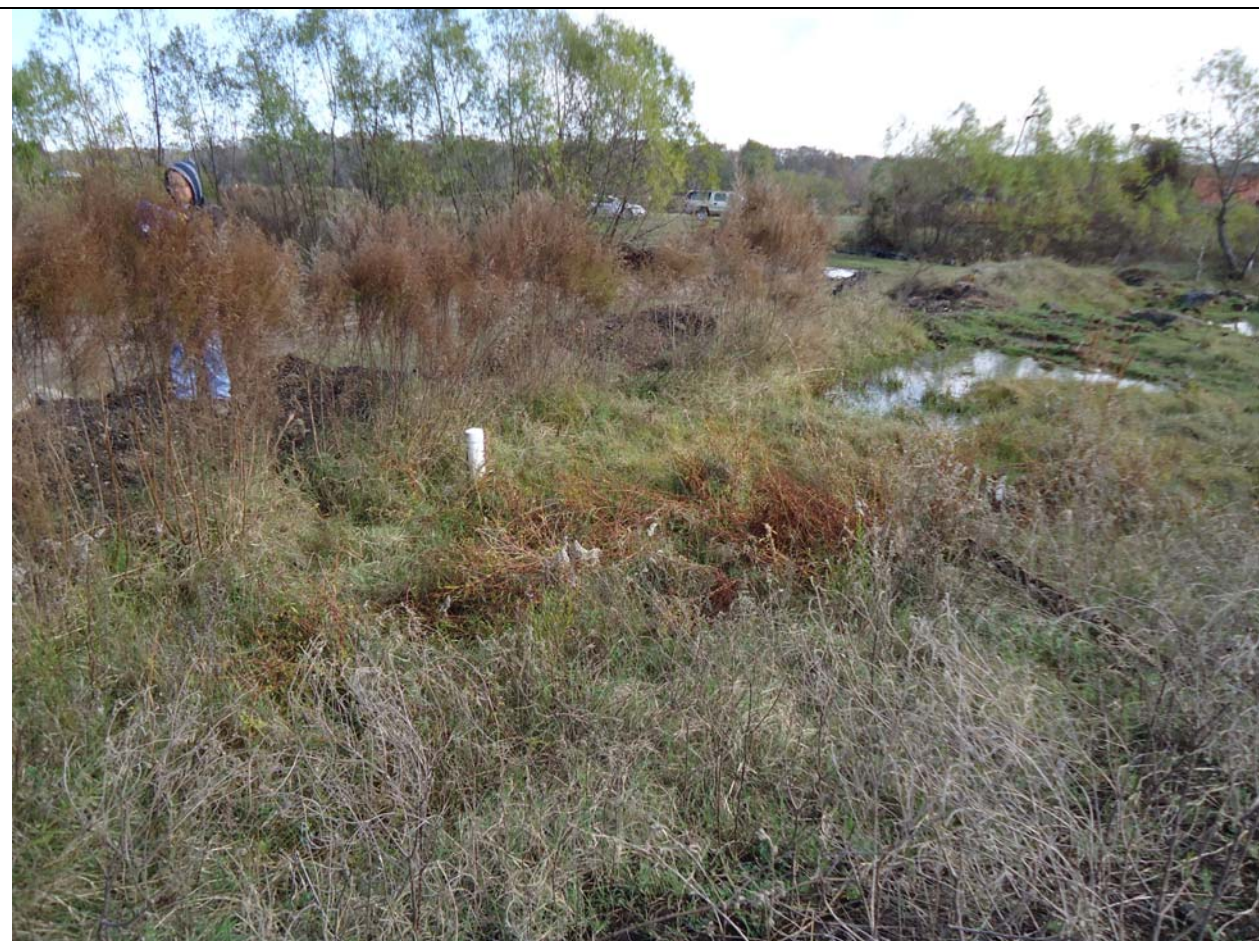
Logbook Photo #	DSC00125
US EPA CERCLIS No / Task Order Number	LAD008434185 / TO-0009-12-10-02
Site	SBA Shipyard
Location Address	9040 Castex Landing Road
City, State	Jennings, Louisiana 70546
Parish	Jefferson Davis
Direction/Orientation	West
Date	12/11/12
Time	1021
Photographer	K. Lloyd (START)
Witness	N. Biscocho (START)
Description: Monitor well near former tank location.

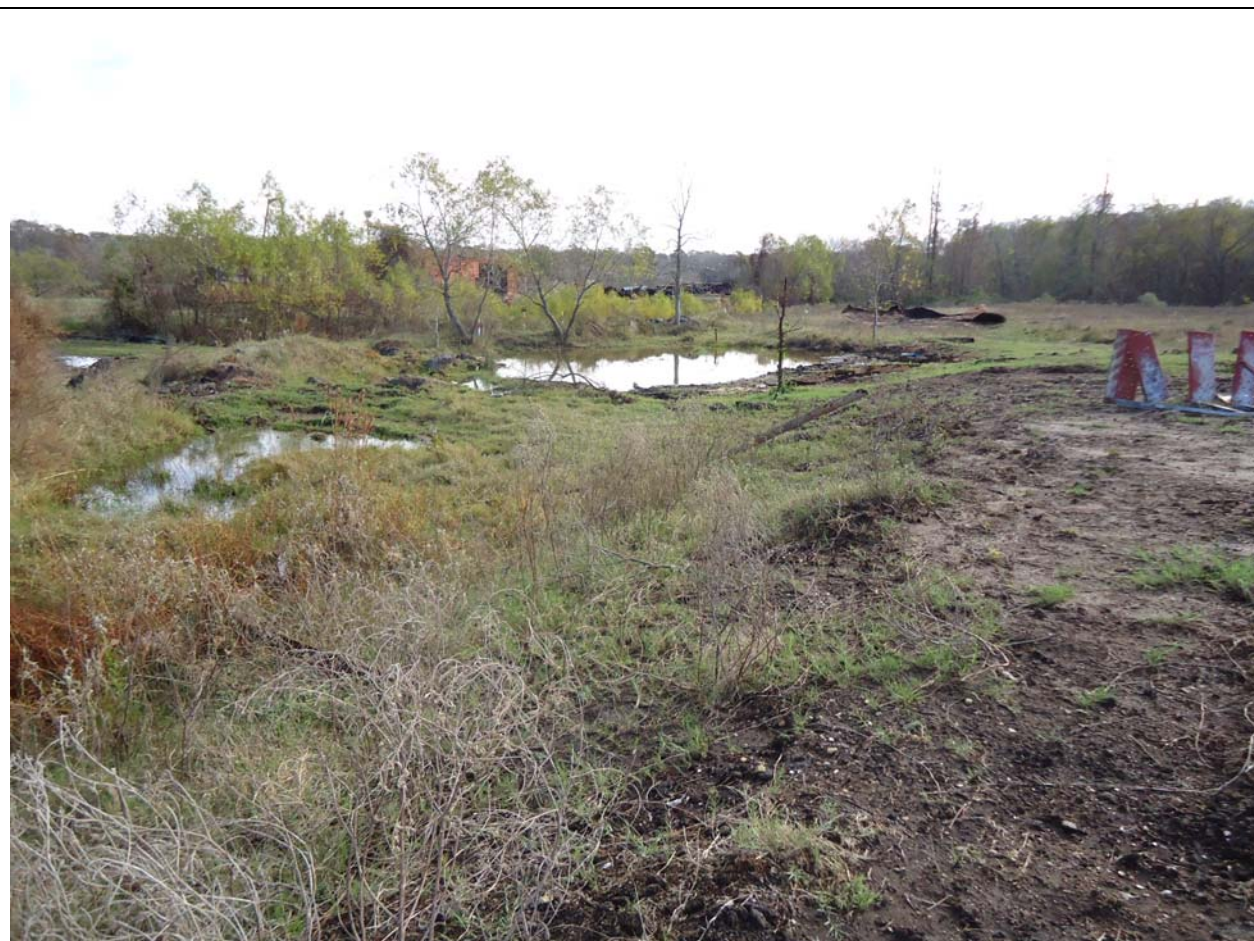
Logbook Photo #	DSC00126
US EPA CERCLIS No / Task Order Number	LAD008434185 / TO-0009-12-10-02
Site	SBA Shipyard
Location Address	9040 Castex Landing Road
City, State	Jennings, Louisiana 70546
Parish	Jefferson Davis
Direction/Orientation	East
Date	12/11/12
Time	1021
Photographer	K. Lloyd (START)
Witness	N. Biscocho (START)
Description: Former tank area.

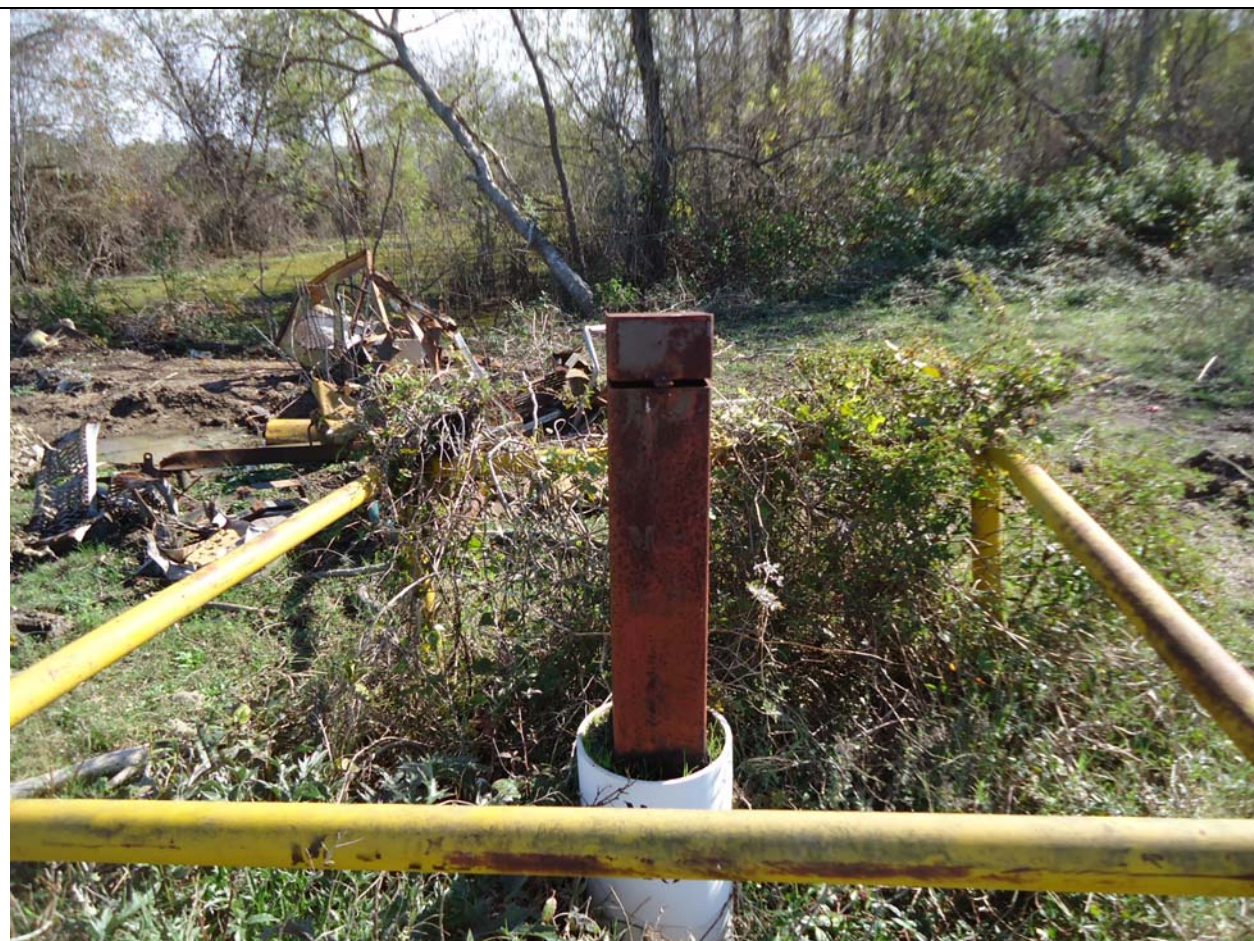
Logbook Photo #	DSC00146
US EPA CERCLIS No / Task Order Number	LAD008434185 / TO-0009-12-10-02
Site	SBA Shipyard
Location Address	9040 Castex Landing Road
City, State	Jennings, Louisiana 70546
Parish	Jefferson Davis
Direction/Orientation	South
Date	12/11/12
Time	1123
Photographer	K. Lloyd (START)
Witness	N. Biscocho (START)
Description: Monitor Well 3 (zoom-in)

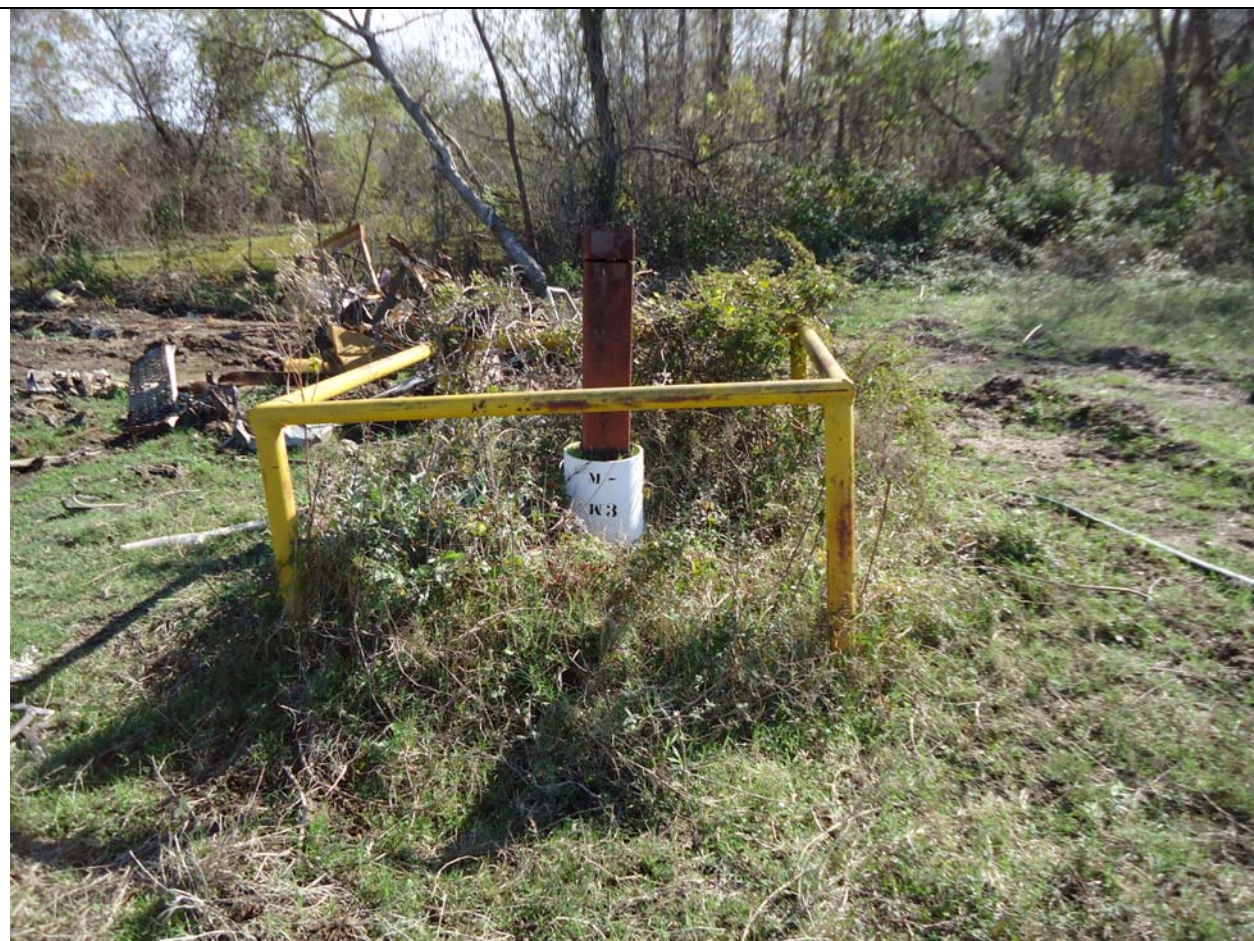
Logbook Photo #	DSC00145
US EPA CERCLIS No / Task Order Number	LAD008434185 / TO-0009-12-10-02
Site	SBA Shipyard
Location Address	9040 Castex Landing Road
City, State	Jennings, Louisiana 70546
Parish	Jefferson Davis
Direction/Orientation	South
Date	12/11/12
Time	1123
Photographer	K. Lloyd (START)
Witness	N. Biscocho (START)
Description: Monitor Well 3 (zoom-out)

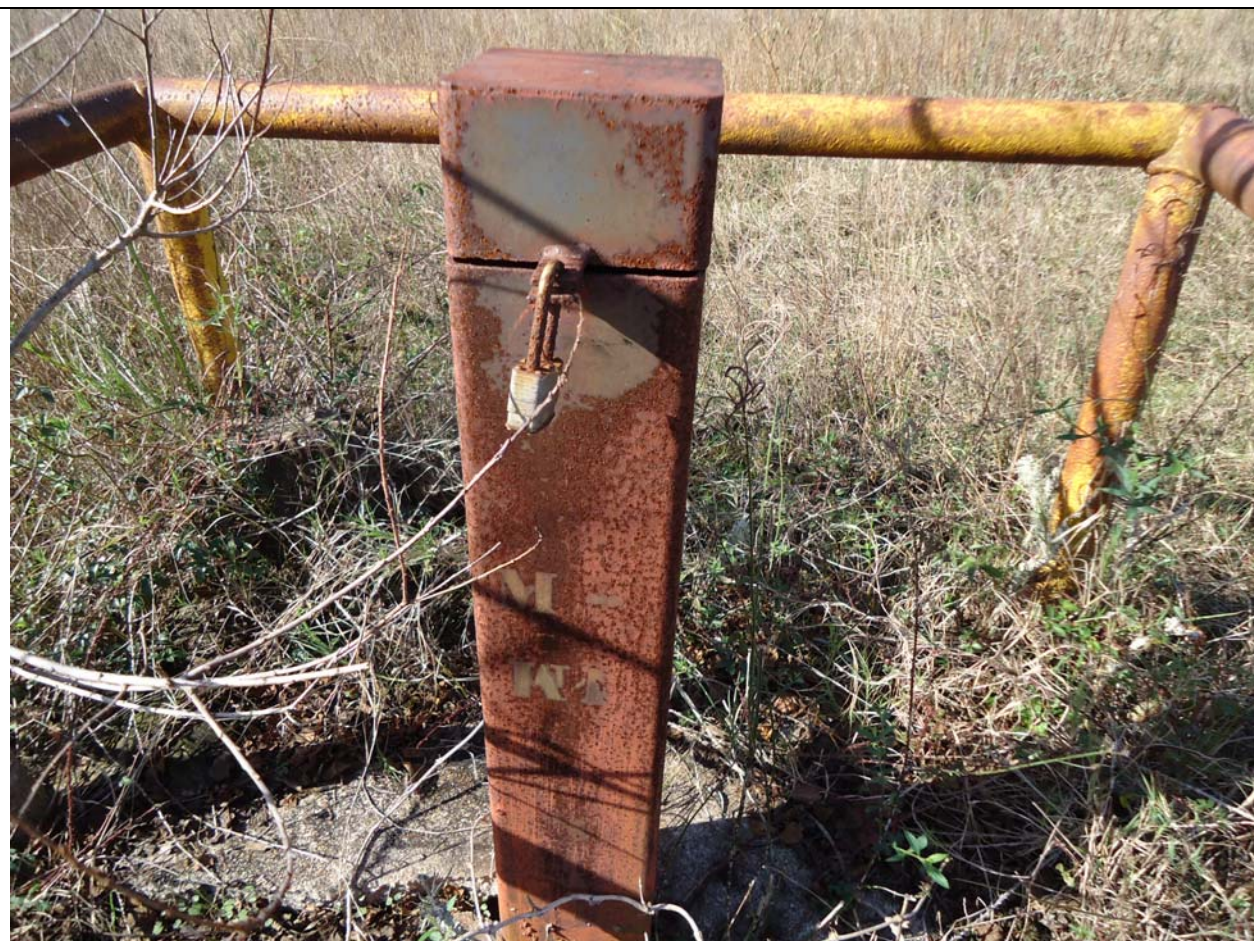
Logbook Photo #	DSC00128
US EPA CERCLIS No / Task Order Number	LAD008434185 / TO-0009-12-10-02
Site	SBA Shipyard
Location Address	9040 Castex Landing Road
City, State	Jennings, Louisiana 70546
Parish	Jefferson Davis
Direction/Orientation	South
Date	12/11/12
Time	1029
Photographer	K. Lloyd (START)
Witness	N. Biscocho (START)
Description: Monitor Well 4 (zoom-in)
